Wastewater Management Editorial

BRL Hardy Winery Berri Woodlot – A Case Study

Sentek Sensor Technologies save BRL Hardy over \$1 million in infrastructure costs by maximising irrigation efficiency.

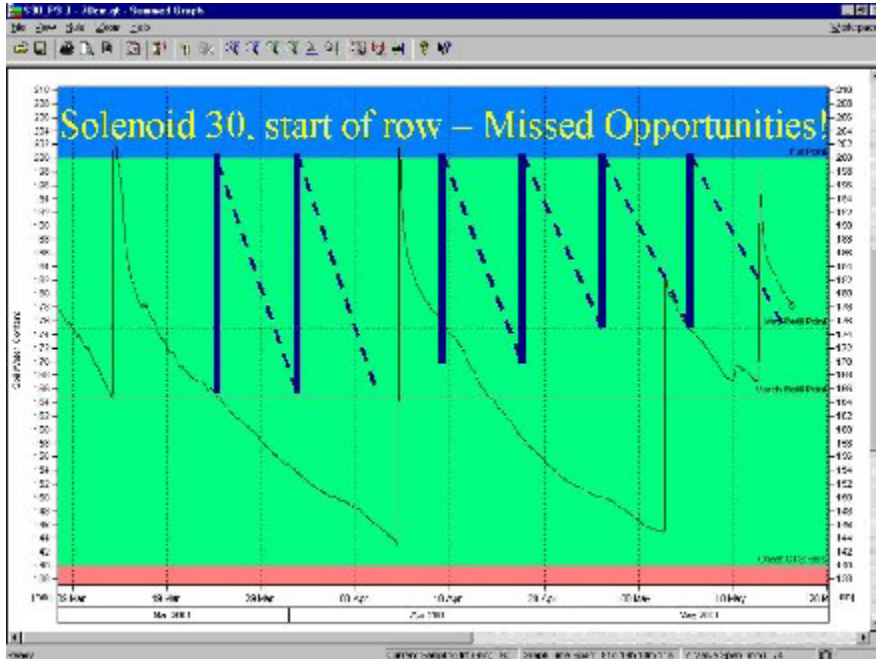
Figure 1 shows data collected from a site where irrigation events were applied without the use of the EnviroSCAN® data as a scheduling tool. Displayed is a graph showing the soil moisture content within the active tree root zone over time. Each solid blue bar shows the missed opportunities for applying wastewater to the site, where the soil moisture has been allowed to drop below the refill point.

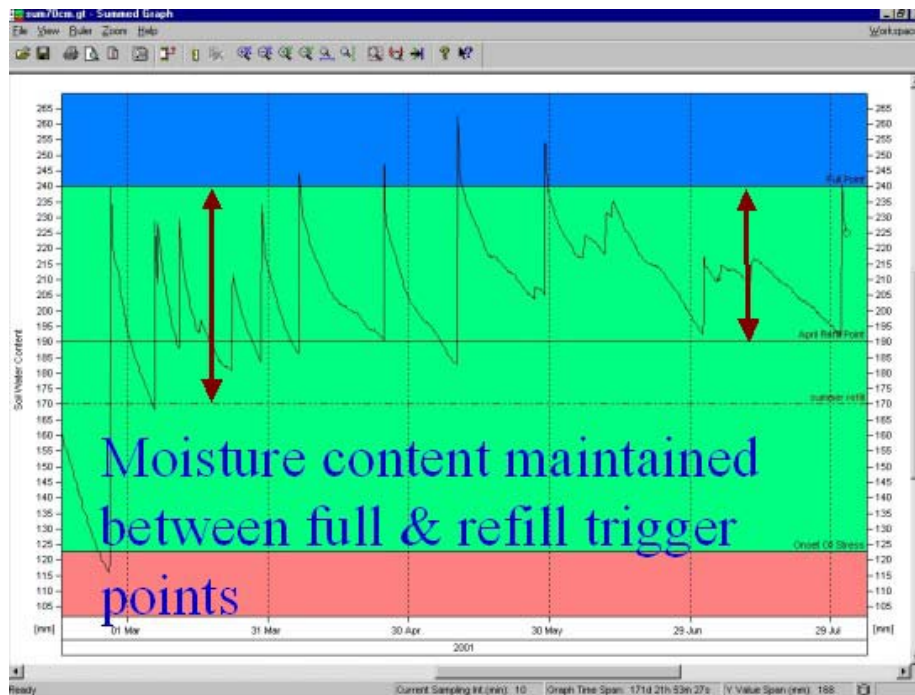
Figure 2 shows a site where the soil moisture is successfully maintained between the full and refill points for the duration of the irrigation period. The data was carefully monitored on a regular basis, and the upper and lower thresholds and other trigger points were adjusted as required. Figure 2 shows how to maximise wastewater application without leaching into the water table.
